## Introduction

During the commissioning of Sea Water System 50, uncontrolled displacement of the pipework has been observed as a result of hydraulic hammering during ESD of sea water lift pump 50-P-130.

Due to the hammering support no. PS-149 failed to restrain the pipe in lateral direction.

Preliminary results of the water hammer analysis performed by DRG is presented here.

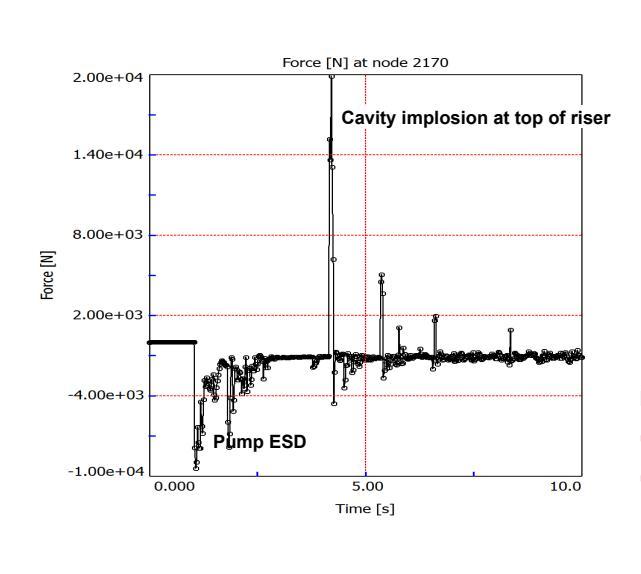
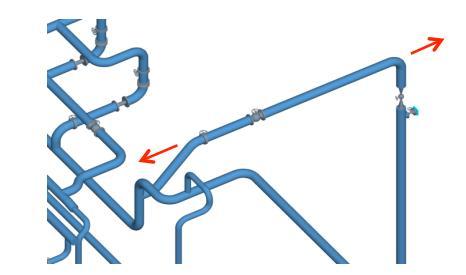
# Pressure pieks result in high unbalanced loads

Force [N] on pipe section 440-2320

Unbalanced load location on pipe section 440-2320

Here two mechanism of unbalanced forces may be observed:

9,5 kN due to pump ESD at t = 1,07s

20 kN due to cavitation at t = 4,21s. This cavity is greatly influenced by air from the air valve that might find its way downstream of the check valve

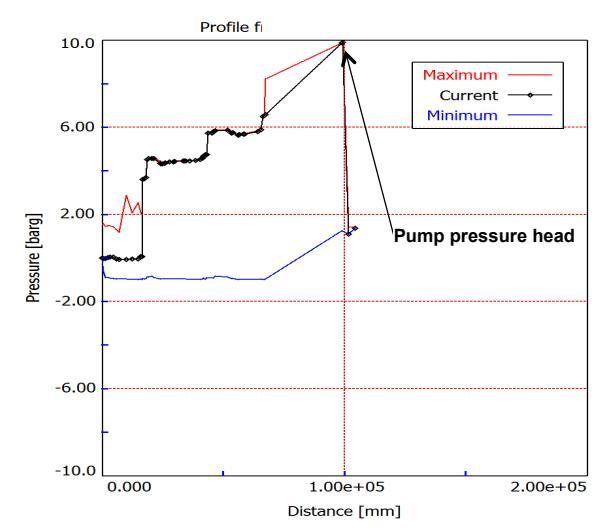
Figure showing the maximum and minimum pressure along the flow path during the simulation. The current line is the steady-state condition

Two mechanisms are identified that may have caused high unbalanced loads near the support PS149 in the lateral direction: ESD of the pump and cavitation

Unbalanced forces in the order of 10 to 20 kN may be observed during ESD

Cavitation forces might possibly be large enough to also move PS150 or PS148. Caesar analysis will determine that

No pressure peaks above the operational pump head are observed during the entire simulation.

NB. Cavity might not collapse (not creating any unbalanced forces) if the TDL valve is allowed to open again and let air into the system through the air valve.
